# Strukturální dysfunkce bioprotéz

## Echokardiografie a další neinvazivní metody

KATEŘINA LINHARTOVÁ

KARDIOCHIRURGICKÉ ODDĚLENÍ FAKULTNÍ NEMOCNICE V PLZNI

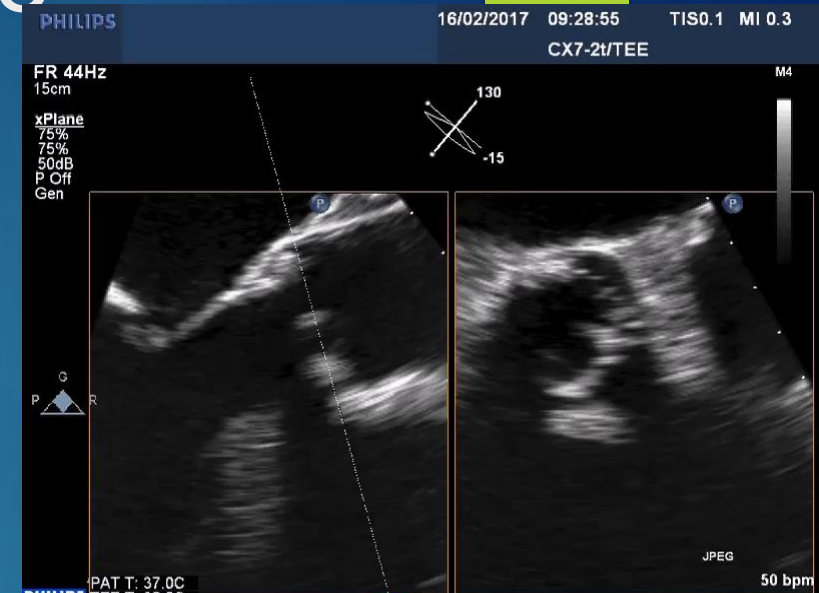
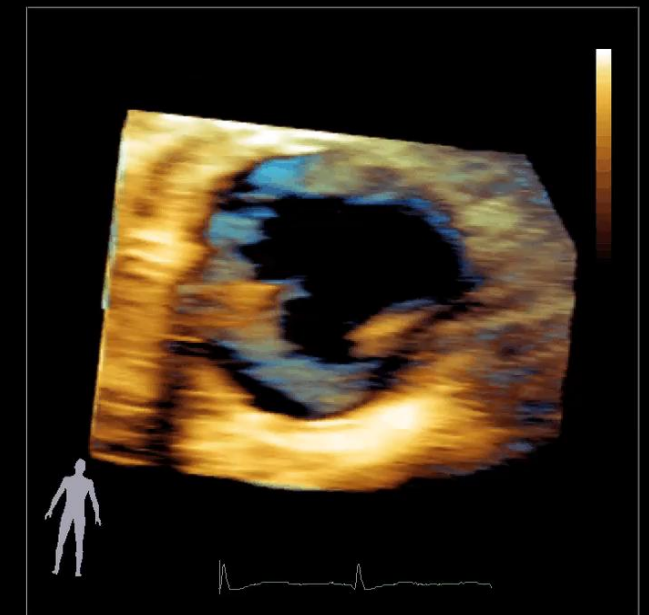
XY, 75 let, náhrada aortální chlopně  
bioprotézou pro stenózu + CABG  
RIA/LIMA 2004, 185 cm, 138 kg

Před op. 1/2003	Poop 8/2004	2011	2017
Max. grad.	56	55	46	60
Střední grad.	33	31		35
LKd	63	54	61	61
IVSd	16	14	15	15
ZSd	16		13	13
EF LK	60	45	59	45

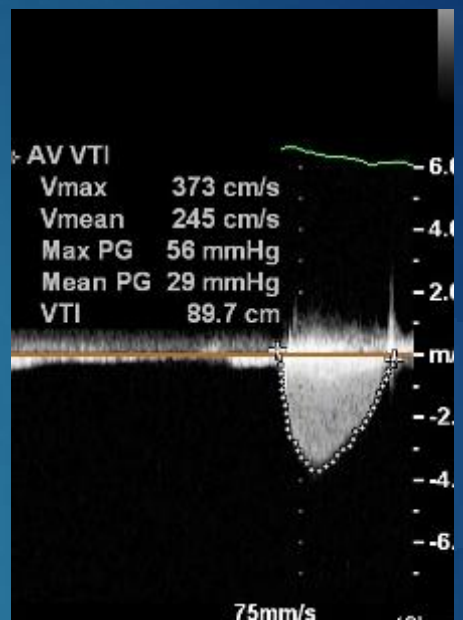
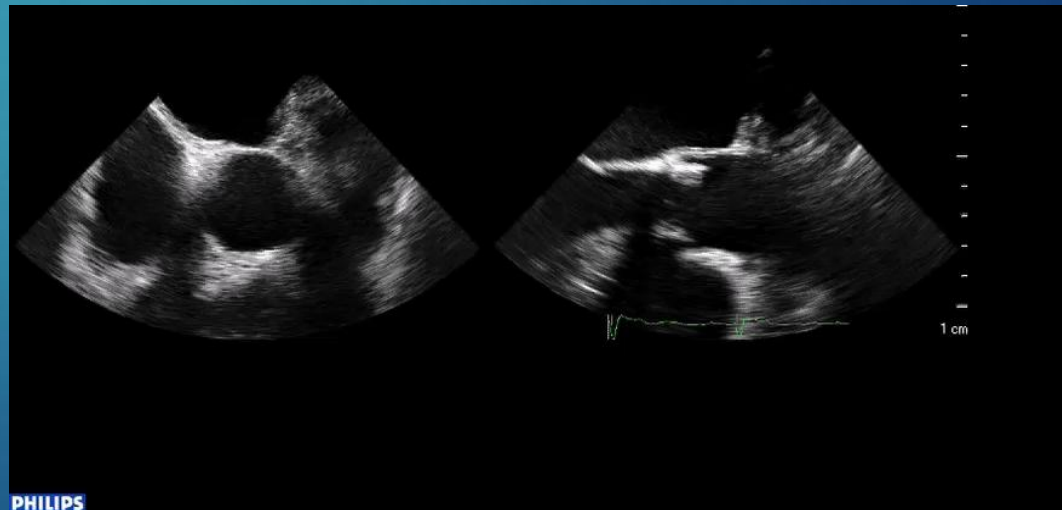
# 67 letý muž 5 let po AVR bioprotézou, nárůst gradientu – morfologie bez patrných zásadních morfolozických změn, antikoagulační tp.

Bioprosthetic thrombosis		
Anticoagulation using a VKA and/or UFH is recommended in bioprosthetic valve thrombosis before considering reintervention.	I	C

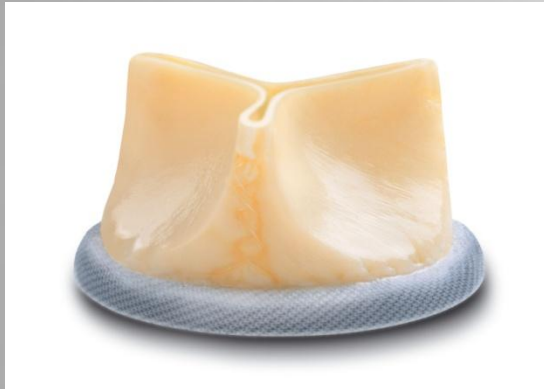
# Design

## Single pericardium layer

Fatigue resistant, offers same tissue properties in every point uniforming mechanical behaviour, optimizes leaflets match, reduces risk of leaflet prolapse. The unique mounting allows for a synchronous and wide leaflet opening

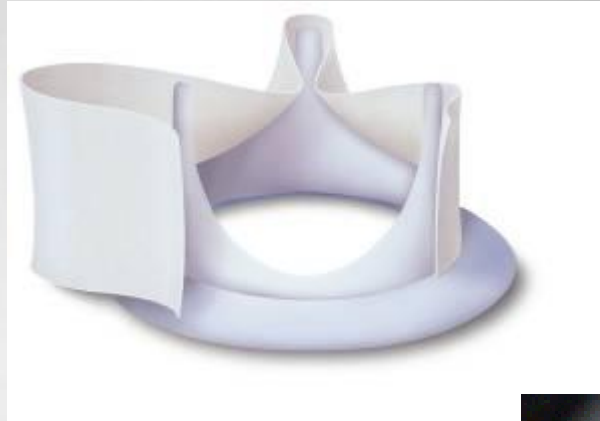
# Leaflet Design

## Tissue Mounted Outside the Stent

- ✦ One single sheet
- ✦ Maximized flow area
- ✦ Synchronous leaflets opening
- ✦ Tissue thickness varies with valve size for greater fatigue resistance and reduced prolapse probability.
- ✦ The tissue is externally cross-sutured to the stent posts
- ✦ The cross stiches are aimed at distributing the stress, avoiding the leaflet tear
